TORWOOD CASTLE EXCAVATIONS

Geoff B Bailey

Falkirk Archaeological Report

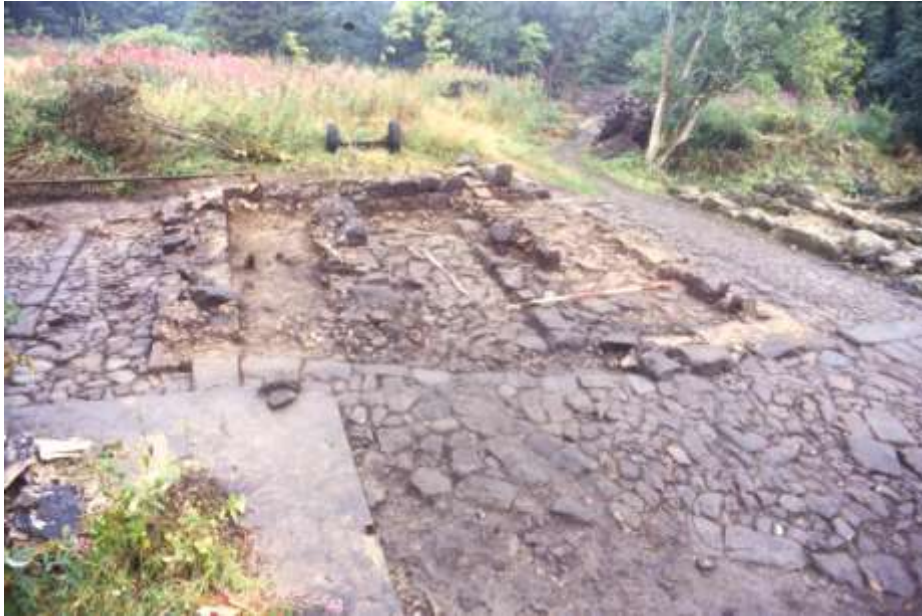
Illus 2: The north range of the courtyard buildings looking north with the pond on the right.

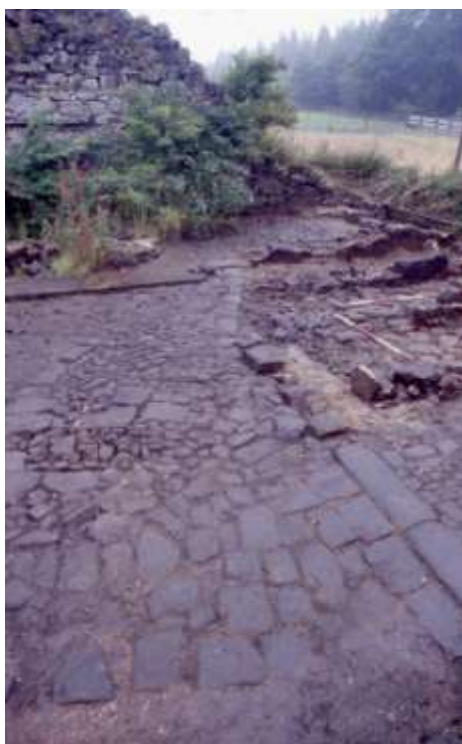
Illus 3: Cobbled path F23 overlying the south wall of the North Wing. Looking WNW.

The construction of this path had necessitated the demolition of a length of the south wall of the range to create the open entrance. The north edging of the path led to the north side of the doorway into Room 1. The cobbled path (F23), shippen (Room 1) and rearranged stable (Rooms 2-4) are all seen as Phase II features of the farmyard.

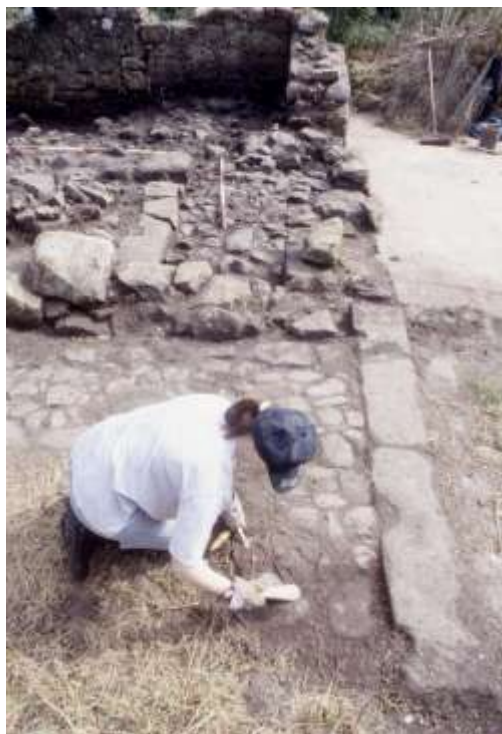
Illus 4: Stone sill at the south end of the pend, looking east.

long sill stone, now broken into three, is embedded 0.2-0.3m into the corners of the side walls. At either end of the sill is a check for the wooden frame of the entrance gates, which would have reduced the width of the passage to c1.8m. It is odd that the sill is a little skew from the perpendicular and it would seem that this was not its original position. At both of the north corners of the pend walls, just where we might expect good quality quoins, the stonework is missing for a depth of only 0.2m. The small size of the voids is more suitable for the ends of the sill stone than for quoins. Certainly it would make more sense to have the gates at the outer end of the pend, with the leaves opening inwards against the side walls, than at the inner end.

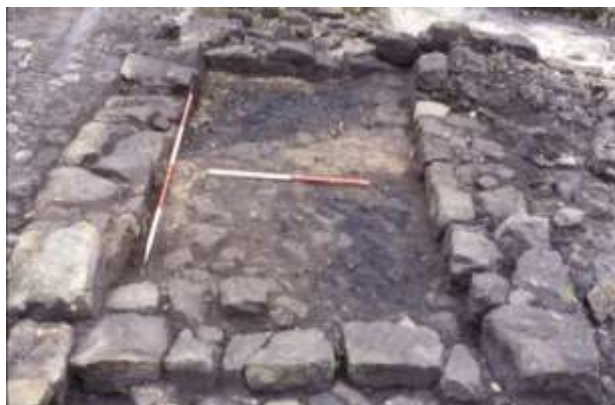
Illus 5: Room 5 looking north with charcoal and mortar on the floor.

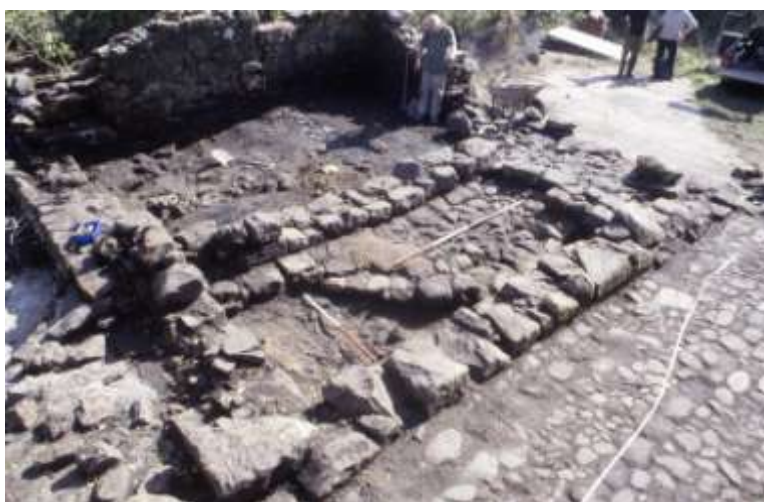
Illus 6: Room 5/6 looking SE with the pend on the right. The line of flat slabs (F130) can be seen below the late wall (F181).

Just to the west of the rough edge a double N/S line of small square blocks (F130) extends 3m south from the north wall. Their tops are smooth and flush with the surface of the cobbles. On the west side a curving 1.3m gap occurs in the cobbling, edged by slightly more rounded stones, partly reddened by heat. The gap was filled with a mixture of charcoal and decayed mortar, suggesting that it was related to patches of yellow mortar attached to the surface of the cobbling just to the south. To the east of this more mortar was found beyond the cobbles and here small sandstone chippings (F121) were set into the orange-brown clay floor, apparently forming a wall foundation. The cobbling in Room 5 and the earth floor in Room 6 were covered with charcoal and coal dust.

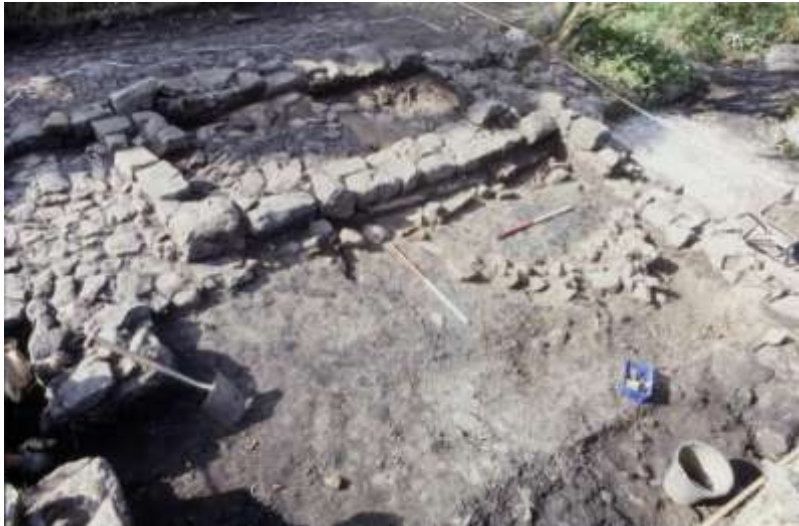
Illus 7: Room 5/6 looking NW.

Along a wide strip in front of the east wall of Room 6 the charcoal incorporated a moderate amount of broken blue slate. It is possible that this derived from the roof of Room 7, but like the slate below the floor levels in Room 7 it is probable

that it represents levelling material. The suggested sequence can be represented diagrammatically as in illus x-xx. The burning, charcoal, coal dust and the existence of a mortared structure in the NW corner of Room 5/6 suggests that this was the bakehouse for the castle, appropriately positioned adjacent to the well room (Room 7).

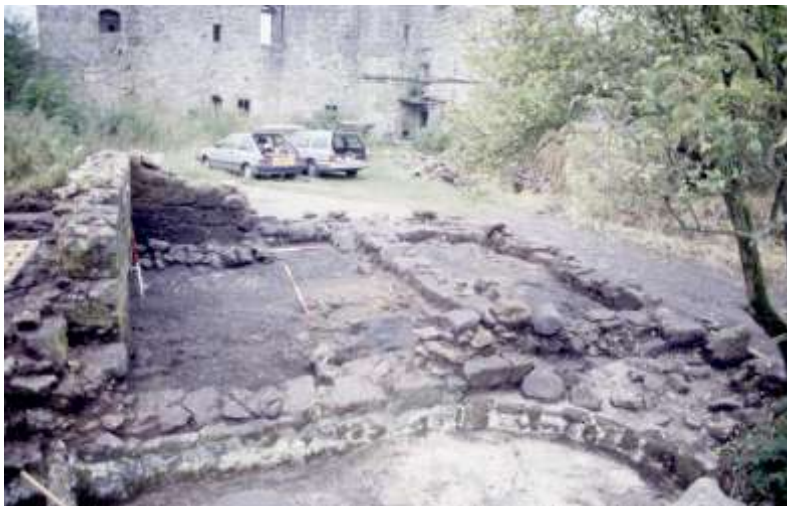
Illus 8: Room 5/6 looking SSW with the 1950s concrete duck pond in foreground.

At a comparatively late date two crude walls were built on the cobbling of Room 5/6 to create a large compartment in its NW corner. The N/S wall (F181) was placed at a slight skew to the

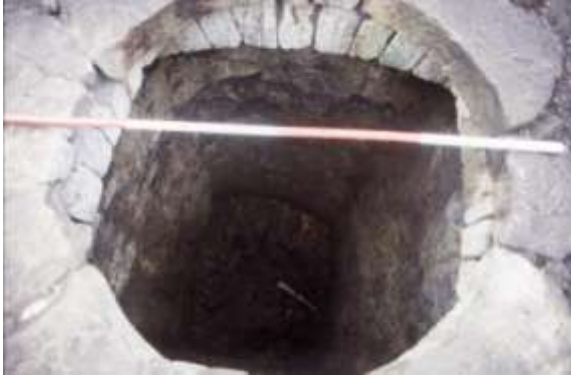
Illus 9: The well head showing the masonry arches.

water table and currently has a dog skeleton on the top of the remaining fill. The bedrock reaches close to the surface and is levelled off with closely fitting stone. As noted by the RCAHMS, it is curiously vaulted, having segmental arches north and south supporting subsidiary transverse arches to form a small square aperture, which then had a circular opening of 1.5m diameter superimposed upon it using broad flat slabs.

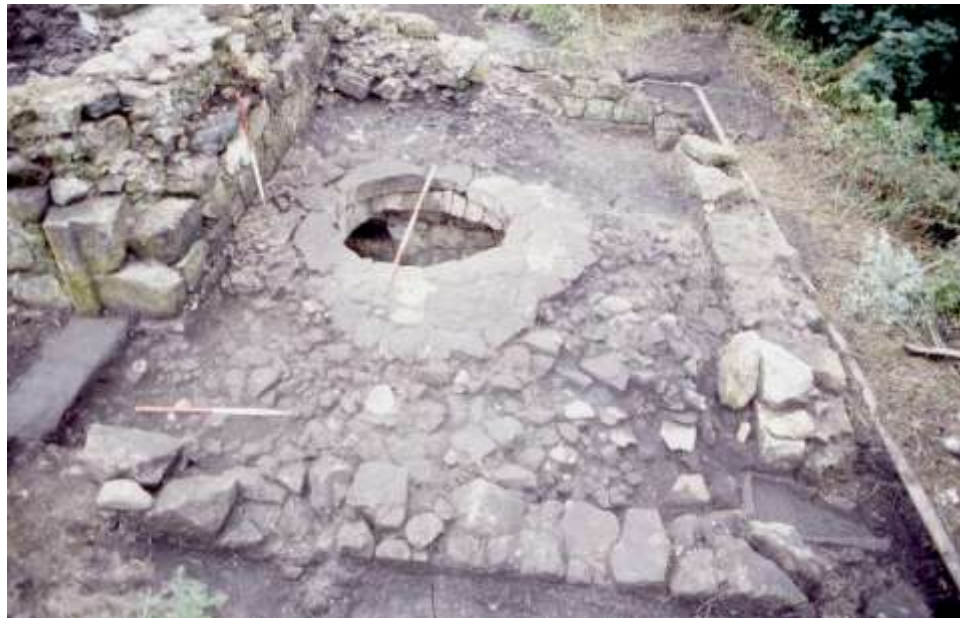
Illus 10: The wellhead in its setting looking east. The stone trough can be seen passing through the outer wall on the lower right opposite the doorway.

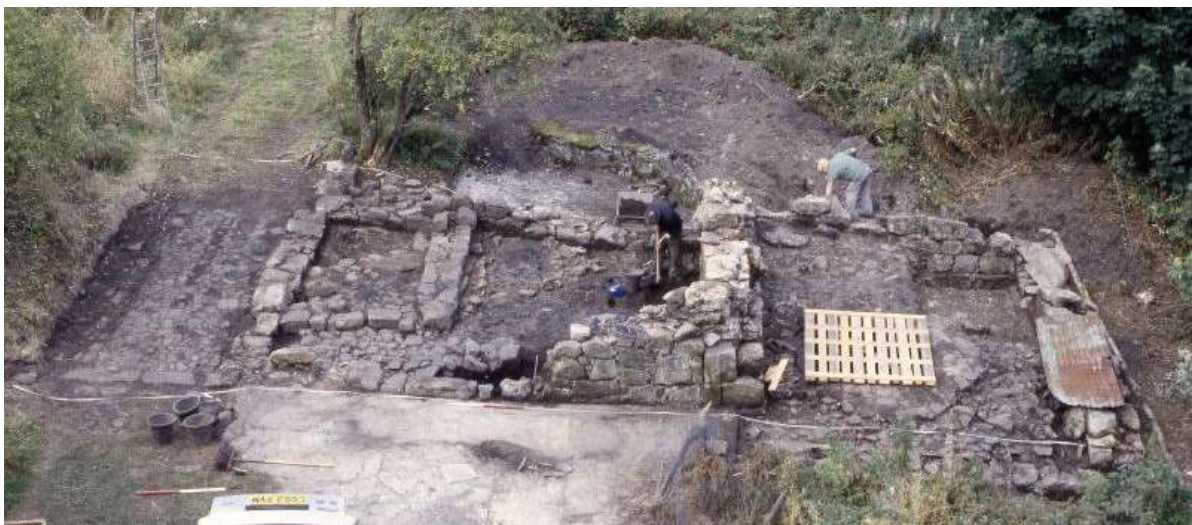
Illus 12: The North Wing with the pend on the left and the well room on the right. A cover now protects the well.

The Pend. In the centre of the North Range is a cobbled passageway or pend 2.0m wide. The cobbling is slightly cambered and made of small worn blocks of hard sandstone with three N/S ribs of larger stone. The spinal rib occupies the ridge and has the largest stones arranged with their straightest edges on the west. The side ribs are placed close to the sides of the passageway with their centres 1.65m (5 ½ ft) apart – the gauge of a cart. Although not as neatly laid out as the central row, they have their straighter sides facing the walls. At present the cobbling stops short of the outer face of the north wall of the range in a rough line. This contrasts sharply with the southern end where a single

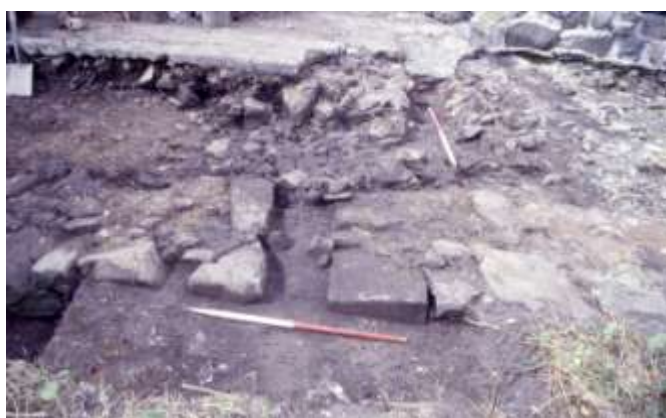
Illus 13: Drain in the east wall of Room 9, looking west, with late road metalling inside the room.

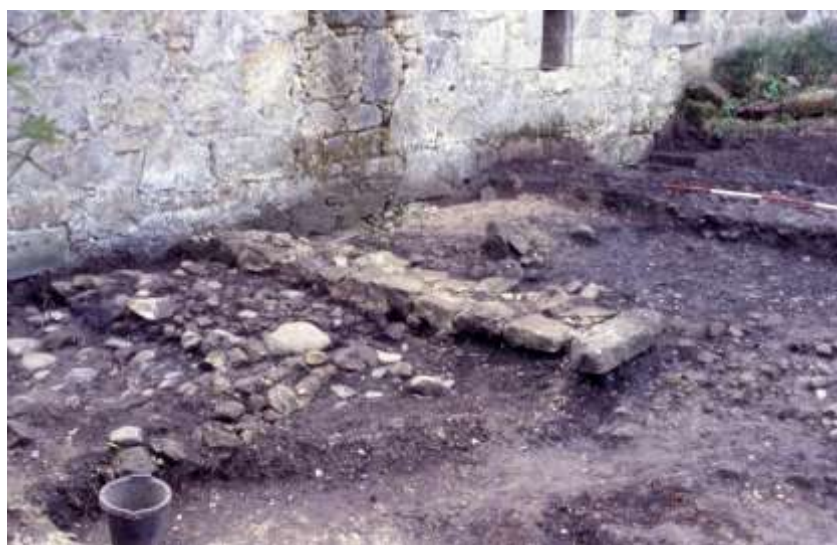
Illus 14: Wall F240 on top of the courtyard surfaces.

3.5m from the foot of the castle wall. At 1.8m west of the north-east corner of the castle block a 0.6m wide stone wall (F240) lay on top of this surface. It extended perpendicularly for 3.8m, terminating in a slight expansion. Flush with the gravel surface of F234 and 5.5m west of end of F240 were two flat rectangular stones (F239), which had evidently served as post pads. Small vertical slots in the face of the castle block set at a height of around 3m in this area suggest that F240 and F239 were part of a leanto building with an open front.

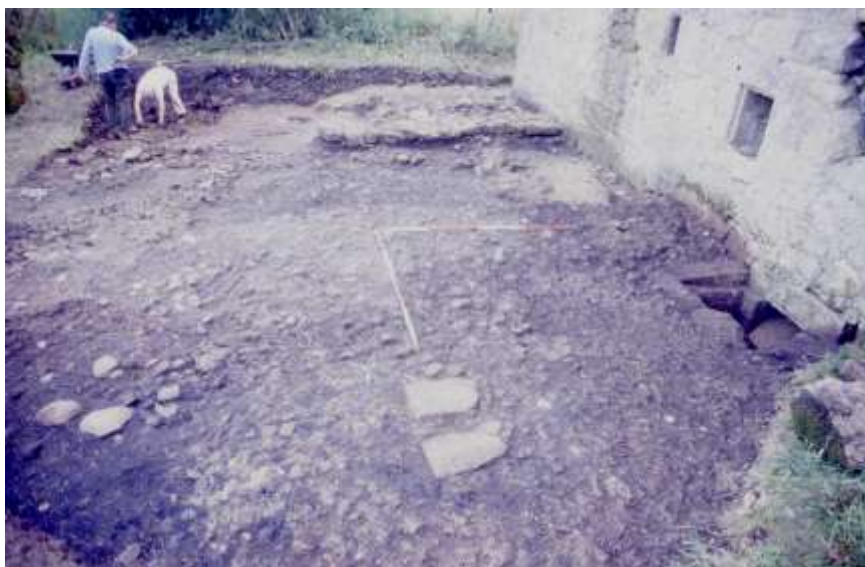
Illus 15: Courtyard metalling with post pads (F239) in the foreground.

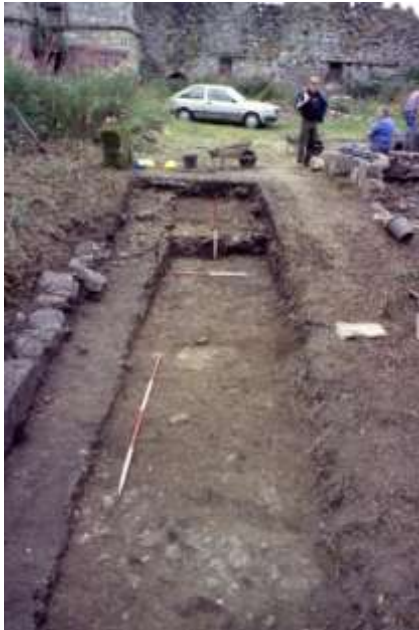
Illus 16: Trench A looking west.

Trench A, 2m wide, was excavated for a distance of 6m from the external wall of the East Wing adjacent to Room 8 in order to examine the topographic setting of the courtyard structures. Here again features created by Gordon Millar were found and the south side of the trench was formed by a line of dressed stone (F190) laid within the topsoil. Removal of the topsoil and small stone rubble from the demolition of the East wing showed that the external wall had acted as a retaining wall. The height difference between the sub floor of Room 8 and the contemporary ground was only 0.4m. That external surface consisted of a thin layer of orange-brown clay loam resting on a rocky natural. There was no trace of a ditch or any other defensive feature.

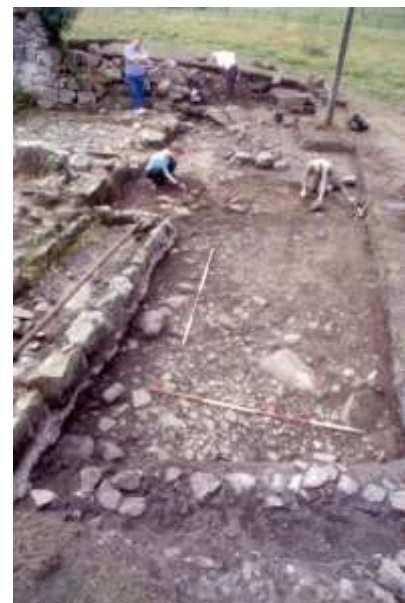
Illus 17: Metalling F210 with tank F202 on the left and the causeway F213 below.

Trench B was laid out over the area to the west of the present access road and in the process the two modern stone tanks were dismantled. Over a large area, immediately below the modern topsoil, was a grey layer of fine grit (F207) up to 5cm deep. This again can be associated with Millar and the keeping of hens. As can a W/E line of post stumps north of F204 which turned perpendicularly to the south at its west end, continuing as a N/S line of stones (F205), evidently used to weigh down the chicken wire.

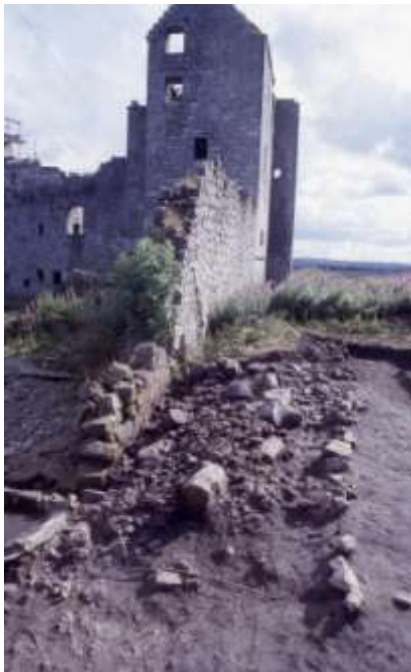
Illus 18: Rubble beyond the east courtyard wall terminating in line F205.

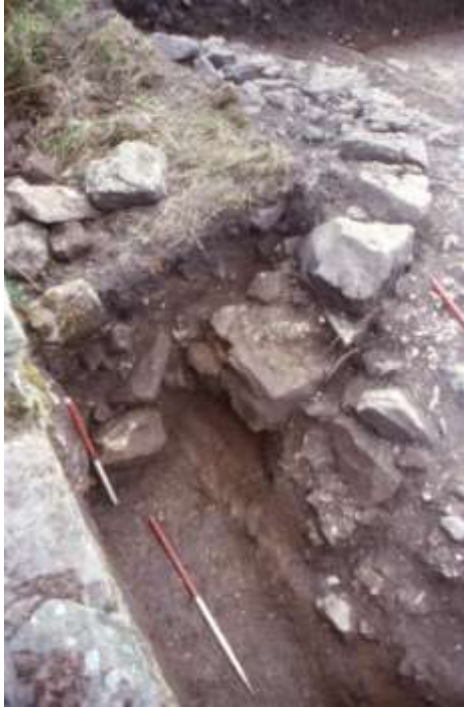
Illus 19: The foundations of the circular tower looking SW with trench F215 in the foreground.

Trench F215 also cut a stone foundation extending westward from the external wall at a point where there is a vertical line in its masonry. Only the upper levels of this foundation were revealed in the 2001 work and it provided the greatest surprise of the excavation. The circular stone foundation of a previously unknown tower was uncovered. At the contemporary ground level it had an external diameter of 3.5m, but this was reduced to 2.7m by an offset at the next course up, making it a rather slender structure. The ground level had been deliberately built up

around the foundation to the level of the offset by as much as 0.5m and sloped rapidly down beyond the front of the tower. This scarp was not matched by a counter scarp, suggesting that this was part of the landscaping designed to highlight the tower rather than being part of a ditch. Over subsequent centuries the area has been levelled off with loamy soils.

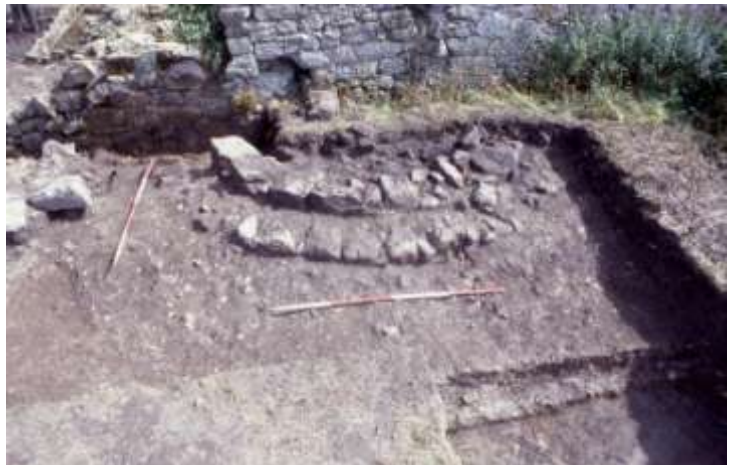
Illus 20: The circular tower foundations looking east.

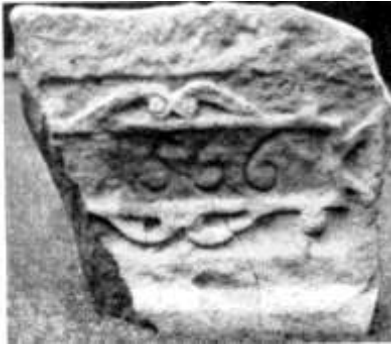
Illus 21: Datestone from Torwood.

The layout and style of the main castle block suggests a mid-16th century date for the initial complex of buildings at Torwood and a datestone of 1566 found almost 200m to the north-west in a stone boundary dyke supports that date (RCAHMS 1963, 337). The date ties in well with a confirmation by James VI in July 1567 of the office of forester and of the lands of Torwood to Alexander Forrester of Garden. The document includes the phrase “as also of building a mansion of stone and lime, with policies and plantations corresponding thereto” (Fleming 1902, 169). It is around this time, in 1588, that the expression “with fortalice and mansion” first appears in connection with the lands of Torwoodhead (RMS v.1567). No white gritty wares, Scarborough Wares or material of an earlier date, were found on the site and so it would seem that the castle was built *de nouveau* at that time. The sophisticated layout of the rooms in the castle and the deliberate disposition of architectural embellishment indicate that the layout was carefully considered and that the courtyard buildings should be examined with that in mind.

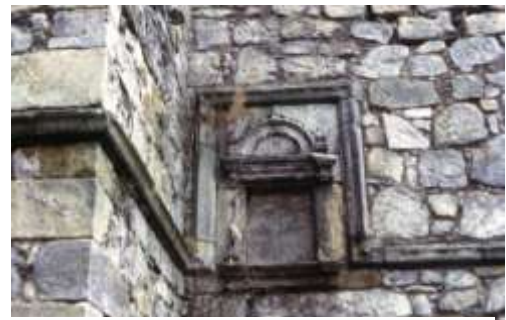
Illus 22: Ornate panel above the entrance.

The ornate surround of this heraldic panel consisted of pilasters and a foliate shell tympanum. This in turn was set within a moulded frame created by turning a string course around it. The moulded string course continues to either side and is echoed on the ground by a deeply chamfered plinth course. Horizontal oval gun loops cover the entrance from different directions. In combination these

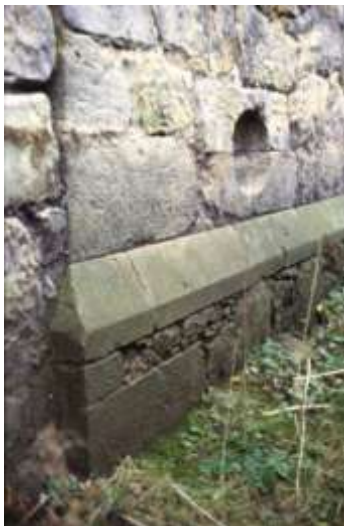
Illus 25: The chamfered plinth at the north-west corner of the tower with gun loop above. Looking SE.

Getting closer more details would be seen. A prominent chamfered plinth course extended from the centre of the main gable to the courtyard entrance and above it were two of the iconic gun loops. A third of these came into view in the protruding gable segment sweeping the foot of that wall and the courtyard entrance. Offset from the plinth course was the moulded string course, beginning not at the centre of the hall gable, but on line with the otherwise indiscernible corner of the tower – an unexpected and thus bold statement. It was mirrored at the top of the large tower by a moulded eaves course. In between was a vertical string of centrally placed windows, also with good quality mouldings. This harsh symmetry contrasted strongly with the disposition of window apertures in the gable of the hall. These varied greatly in size, and placement. Most conspicuous was the large picture window on the first floor at the end of the hall. The protruding segment of the hall gable had only small apertures for the stairs. Even this small amount was more than that possessed by the wall curtain in the centre. As we now have it this is surprisingly blank. However, if the entrance was in this area it would have lain at the foot of the large tower in order to incorporate the gun loops on its north side into the procession. The entrance arch would have needed to be lofty so that it left the moulded string course of the tower visible, leaving a large void in an otherwise blank wall – an area of transition from the well-appointed tower. Above the arch there was probably a decorative panel, which may have incorporated the 1566 datestone.

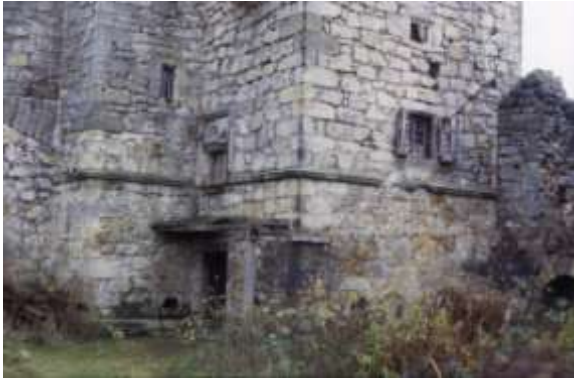
Illus 34: The foot of the tower with wooden shutters and porch still in place. The fireplace on the right is also a Miller feature.

formed off the ceremonial staircase on the first floor of the tower. The wooden shutters on the windows here are a reminder of his occupation. He also established a smallholding, raising pigs, poultry and vegetables. A concrete floor was laid in the old West Wing as far north as Room 1 and the area was enclosed with tall wooden posts supporting chicken wire. The tree that had stood in the south end of the east wing was removed and dwarf stone walls and columns built in its place to provide the bases of greenhouses. Small rubble from the clearance of these sites was piled up on the area of the North Wing. There was no water supply and so a pipe was led from the farmer's cattle trough into the concrete-lined tanks and ponds mentioned above. Gordon bathed in the pond, as did the ducks. Poultry were kept in large enclosures to the north-west of the courtyard.

In the 1970s this romantic looking farmstead in a ruined castle was chosen as a film setting for an episode of the BBC drama called "Dr Finlay's Casebook". For the show a false window frame was inserted into the window aperture in the withdrawing room and an open timber porch covered by corrugated felt painted to look like rusting tin; both features being subsequently retained.
