## Excavations in Vicar Street in 1985

Geoff B Bailey

### Introduction

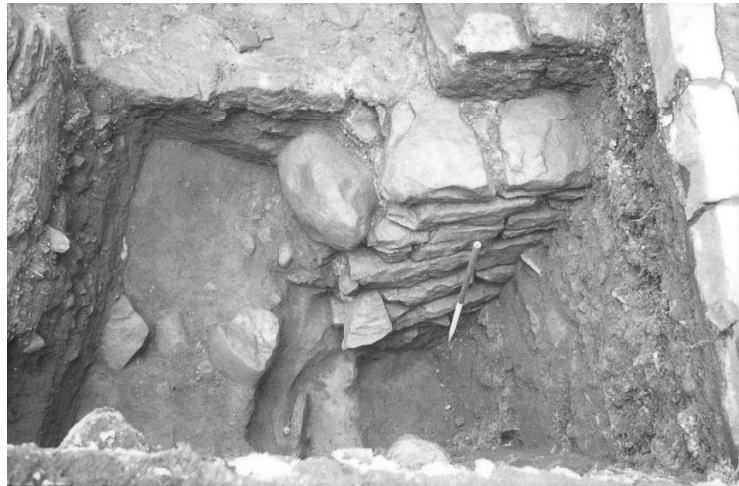
**Illus: Plan of Phase II.**

The foundation for a light rubble wall (F107) aligned north/south was found to the south of F102, displaced slightly to the east. At the south end it returned to the east (F108) but was badly cut up and disturbed by later features. No bonding material was observed and it is probable that this was little more than a dwarf drystone wall to support a timber superstructure – Building 1. Only two courses could be confirmed in the excavation. It could not be stratigraphically related to the more substantial foundation F102 but is the earliest feature to its south.

**Illus: Trench A looking north. Foundation 107/108 can be seen running along the centre of the trench to the right of the much later wall foundation F125.**

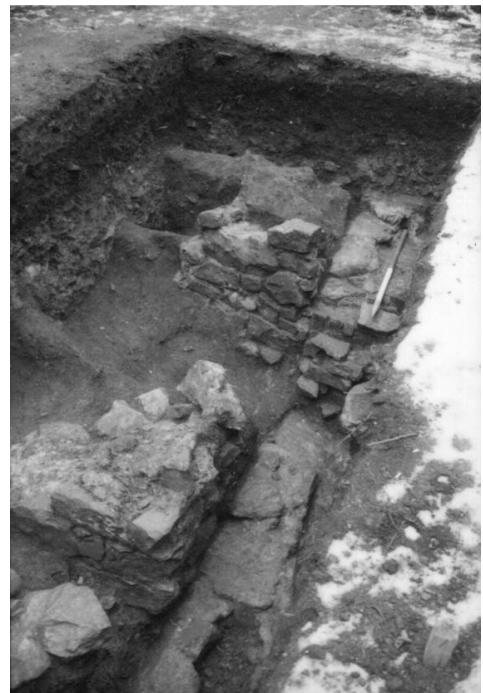
The vestiges of walls F111 and F112 lay against F115. This wall was not examined in detail as its upper levels had been rebuilt as a lime mortared wall (F150) slightly to the east leaving a small offset. At its northern end the earlier wall extended 0.35m beyond F150 and here there was a hint of another return (F110) to the west - destroyed by later pits. Together all of these walls make up Building 2.

### Illus: Wall foundation 125 runs along the right side of Trench A with the clay-bonded walls F113 and F112 at right angles.

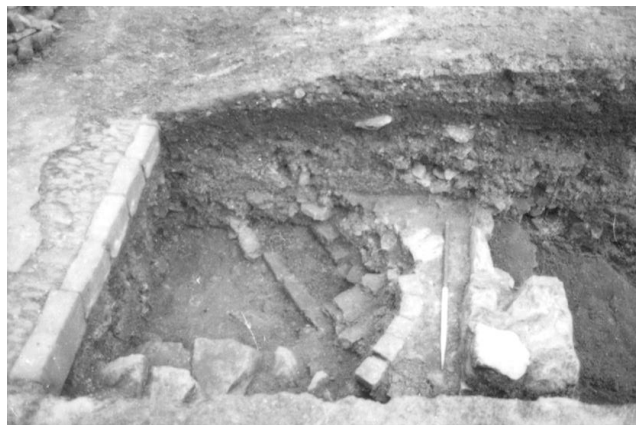
Two patches of beaten earth which incorporated small stones and clay occurred to the east of wall F125. The northern of these (F141) provided the setting for a series of ovens/furnaces. The first of these was a simple hearth consisting of burnt flat sandstone slabs in oxidised clay placed in a slight pit 0.5m wide and over 0.85m long (F143). It was aligned SW/NE and extended beyond Trench A. It was replaced by a similar shaped hearth on the same alignment edged with ordinary hand-made bricks (F145). This contained a brick's depth (0.14m) of charcoal when excavated. Finally an outer curving kerb of refractory

bricks (F147) had been set between F145 and the back wall of the building (F125) at a slightly higher level. All of these hearths probably served as boilers and comparison may be made with the figure-of-eight structure attached to the east side of the northern extension of the bank building (the building to the east of the excavation site) and shown on the 1858 and 1862 Ordnance Survey plans of the town. On the 1858 building it is captioned "boiler". No covered roof is shown for it making it directly comparable with F143/145/147.

**Illus: The north end of Trench A showing the furnace F145 below F147.**

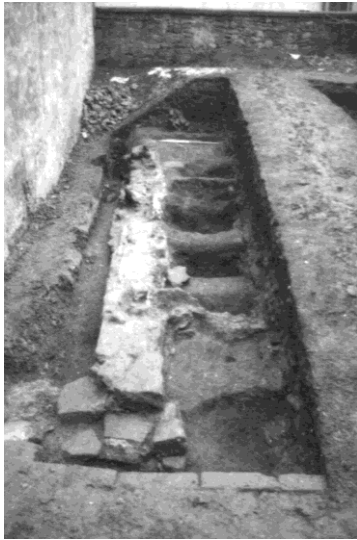
To the east of the Vicar Street building and its associated back yards another building, Building 4, was erected. Wall F150 was constructed on the foundation of F115 but now it returned to the east. The 0.4m thick wall was bonded with mortar and only its foundation survived.

**Illus: Wall 150 in Trench B looking north.**

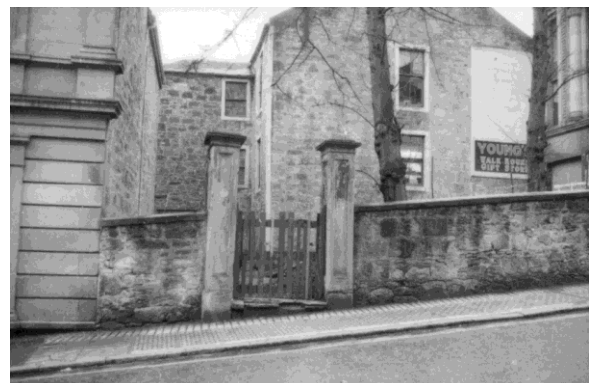
After the demolition of Building 3 that path was replaced by a more substantial one (F170) leading directly to Vicar Street and it is this which is shown on the 1858 OS plan. From the square gate piers at the entrance the path led to the back

door with a formal garden to the south. The path was composed of whinstone kerbs set parallel with it and packed with whinstone chippings set perpendicularly.

**Illus: The Vicar Street entrance in 1985.**

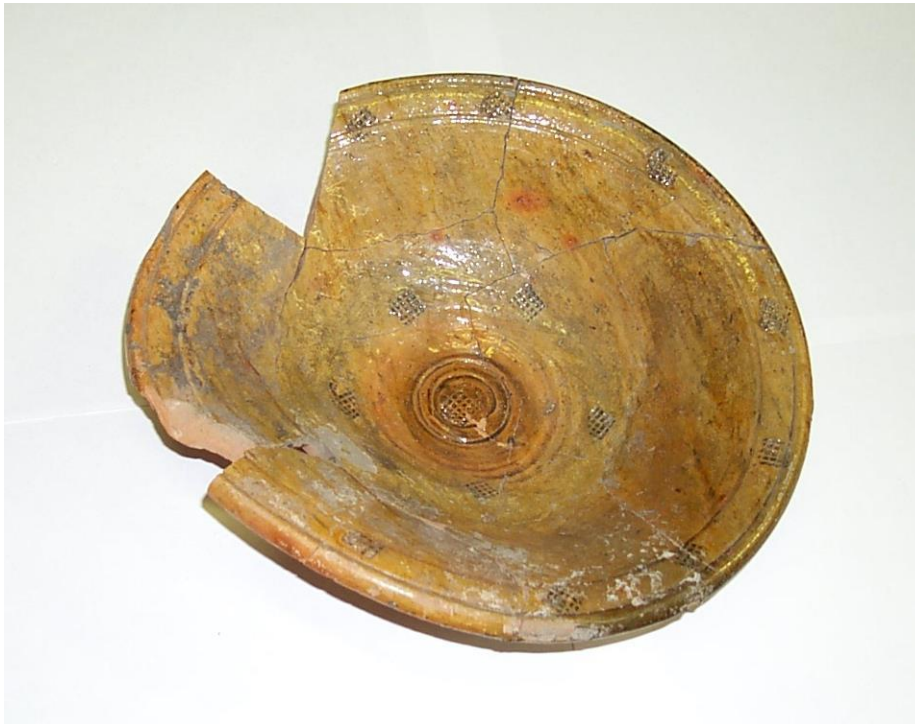
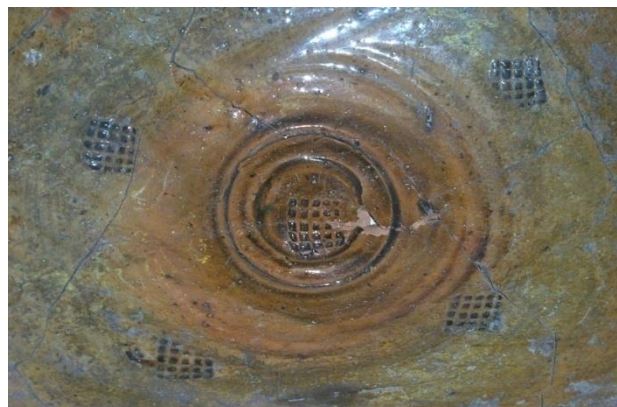
1. Bowl. Almost complete bowl made up of 13 sherds. There is a groove just inside the rim, then a shallow band before two more grooves. The sides slope gently to a small flat base which has two more grooves on the interior. The bowl has a green-glazed interior with impressed stamp decoration. Each stamp consists of a square grid of 25 small squares and the rolling motion of the die can readily be seen (1985-1-4).

There are eleven of these stamps around the band on the rim, one on the inside centre of the base, and five in between. The exterior is not glazed but some of the glaze has run over it from the rim. The distorted – wobbly – form of the body evidently occurred during firing but the bowl would still have been usable. The resulting dimensions were 332mm long by 293mm wide and 93mm tall. (F100).

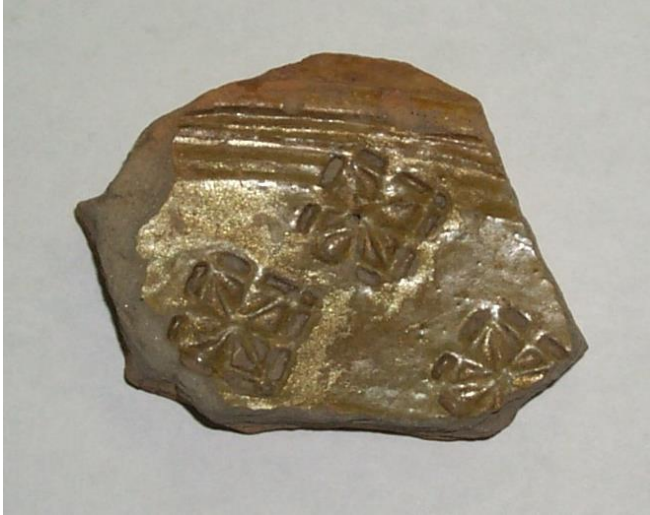
2. Bowl. The rim of a similar bowl but with a more angular lip. There are two grooves near the top of the rim and a different stamp (1985-1-5). The surviving piece is 56mm long and has three closely-spaced stamps. These are square and made up of four petals each with a mid-rub – the outer edges defined by two slots along each side. (F100).

These are high status items and the nearest parallel comes from Linlithgow Palace (Laing 1967, 136-137. No 68) which has

the chequer-pattern stamp and comes from a group dated between 1500 and 1800 but with residual items. It is not unreasonable to assume that the vessels from Vicar Street came from the Earl of Callendar's Lodging and it is probable that that from Booth Place was from the Westquarter Lodging.

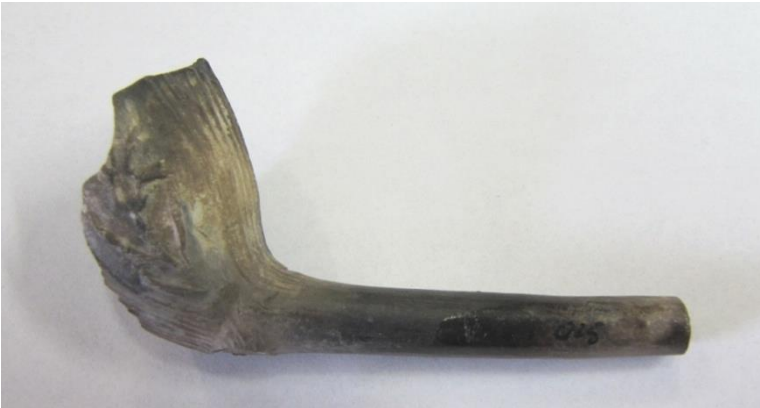
3. Tobacco pipe. Approximately one third of a clay tobacco pipe bowl with part of the stem attached. The decoration on the bowl consists of a flower on either side, with narrow ribbing emanating from the stem. The pointed spur has broken off. (1985-1-7).
