EXCAVATIONS AT NOB ROW, DUNIPACE, 2021

Geoff B Bailey

Excavations at Nob Row 2021

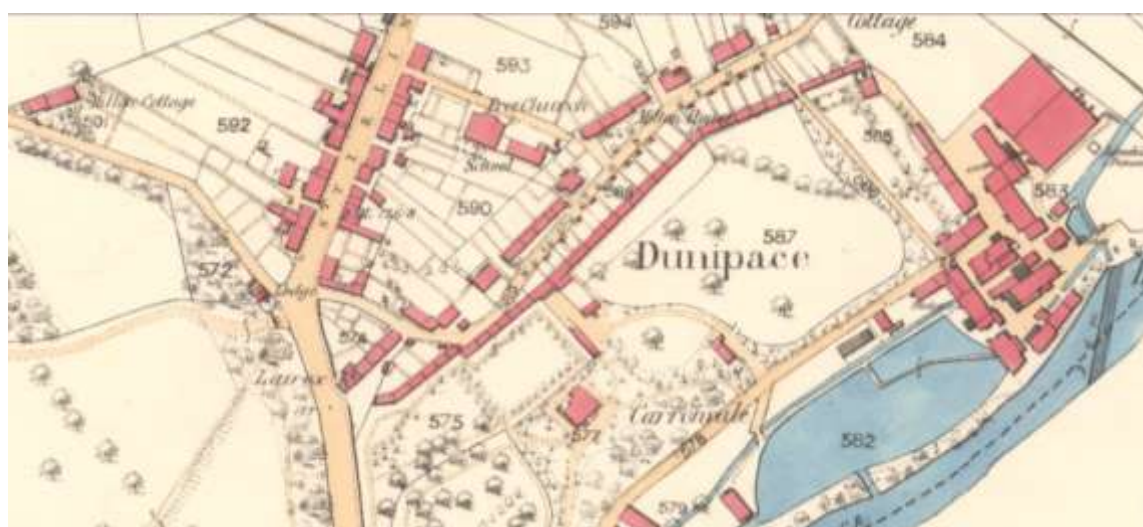
Illus 1: Extract from the 1863 Ordnance Survey Map showing the long line of Nob Row north of Carronvale (National Library of Scotland).

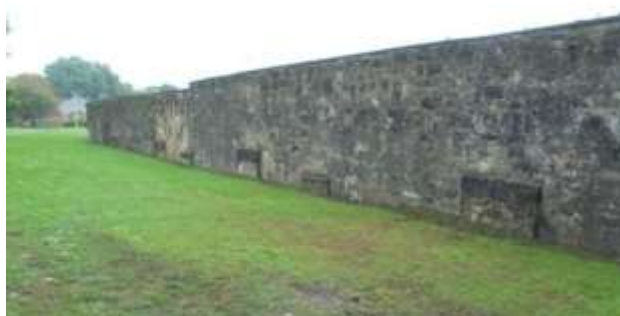
Illus 3: The south wall of Nob Row with alternating tall and short fireplaces.

This wall has the remains of fireplaces consisting of cheek stones supporting broad lintels – all of which stand 5-10cm proud of the wall. These alternate between tall and short ones representing the kitchen and bedrooms

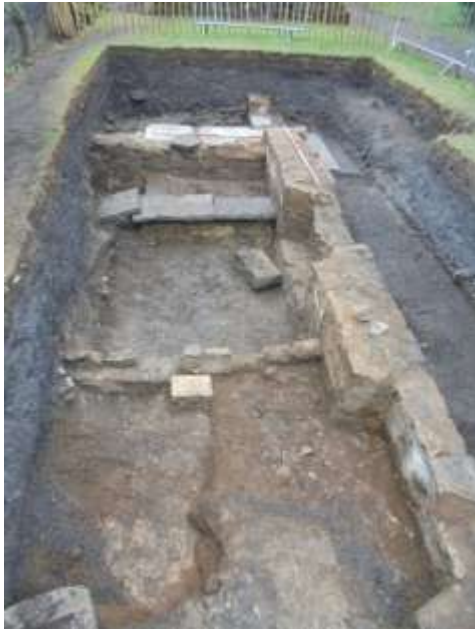
Illus 6: Looking west with Room 1 in the foreground.

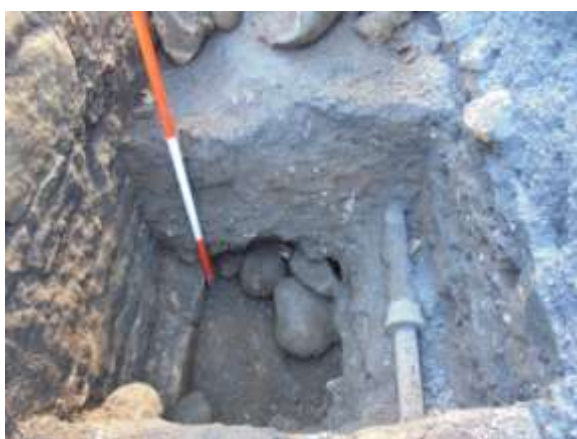
Illus 10: On the left is the front wall of Nob Row with an offset at its foot, in front of this a layer of round boulders covered by soil through which the trench for the water pipe had been cut. The metalling can be seen on the top.

The soil upon which the metalling sat was 0.2m deep and may be associated with the secondary attempts to raise the general ground level in the area to prevent surface water from entering the houses. Despite the initial raising of the ground level at the time of construction there were evidently problems with dampness and at some stage the floors too were raised by a further 0.25-0.30m. In Room 3 the ceramic floor tiles had been lifted and 0.25m of medium brown sandy loam was placed on the original mortar bedding (F33), compacted, and then covered with another layer of mortar bedding (F34) to receive the relaid tiles. In Room 2 the flat slabs of F41 lay on an earlier north/south wall (F9) which extended 1.5m from the north wall before turning west to meet F6. This wall was 0.3m thick

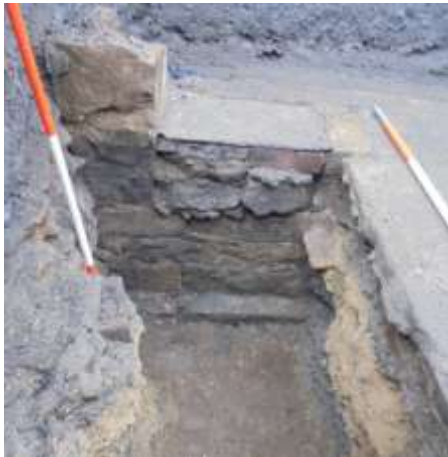
Illus 12: Closet F51 looking north showing the infilling. The ash used to raise the floor can be seen under the cement screed on the right.

The floor in Room 1 had also been raised using a layer of ash (F36). This had necessitated the infilling of the lowest 0.3m of closet F51 with stone and brick and lining the new base with cement.

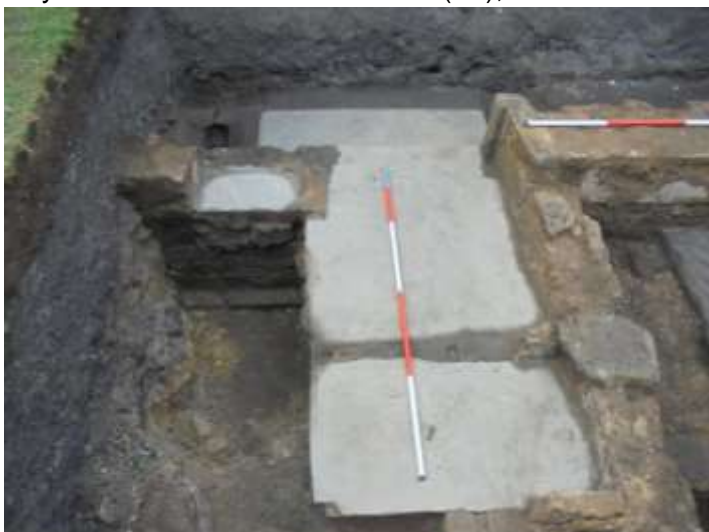
Illus 13: The cement screed in Room 1 showing the cupboard, lobby and entrance doorway – looking north. Post-holes and slots can be seen.

wall. A shallow slot on this line shows that the space between the posts was originally filled with more stones covered with plaster and whitewash. 0.8m further south was a second similar west/east row. The presence of the plastered stones suggests that these were vertical walls rather than stair treads. The inner area would then have been a cupboard for the kitchen and the outer a lobby. Confirmation of the lobby comes from a possible post-hole against the inside of the western door jamb which would have belonged to an internal door frame forming a barrier to external draughts.

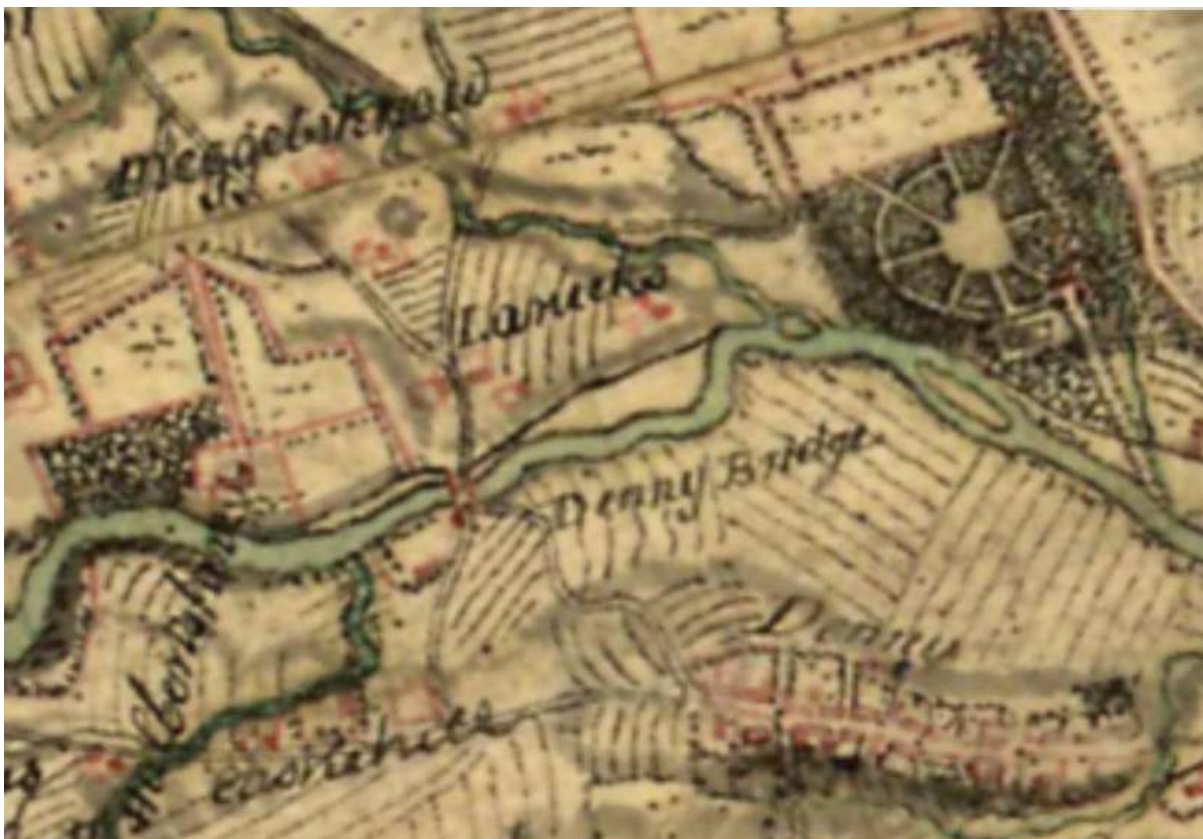
Illus 17: Extract from Roy's 1755 Great Map showing Lairocks (National Library of Scotland).
